# Shortening of two bimetallic urea strippers in situ: extension of the operational life and reliability by refurbishment.

*Two bimetallic urea strippers which had been in service for more than 20 years were reaching the end of their operational life due to corrosion at the bottom tubesheet that affected the tubesheet, the tube protrusion and the tube-to-tubesheet weld joints*

*This paper details a unique restore operation that extended the units' life and reliability by several years and consisted in removing and restoring the tube protrusions and tube-to-tubesheet joints at the bottom tubesheet by shortening the stripper length of 40mm*

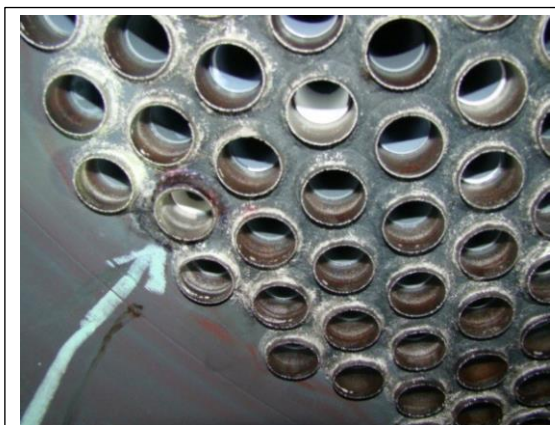
Figure 2: Condition of the bottom TTS welds in 2012

During inspection, severe corrosion in bottom portion of tube to tube sheet weld joints were observed (Figure 2). Weld deposits had developed porosities. During soap solution test, on pressurizing the shell side with air at 3.5 kg cm<sup>-2</sup>, air leak from 13 nos. tube to tube sheet weld joints was observed.

IFFCO tried to carry out the repair of the tubes by welding but the tube ends – which were already thinned-down – would not stand it, and the repair attempt only caused more leaks from the tubes internal surface. Finally all of the 13 tubes were plugged. When welding the plugs, the affected tube-to-tubesheet welds were covered by weld overlay (Figure 3).

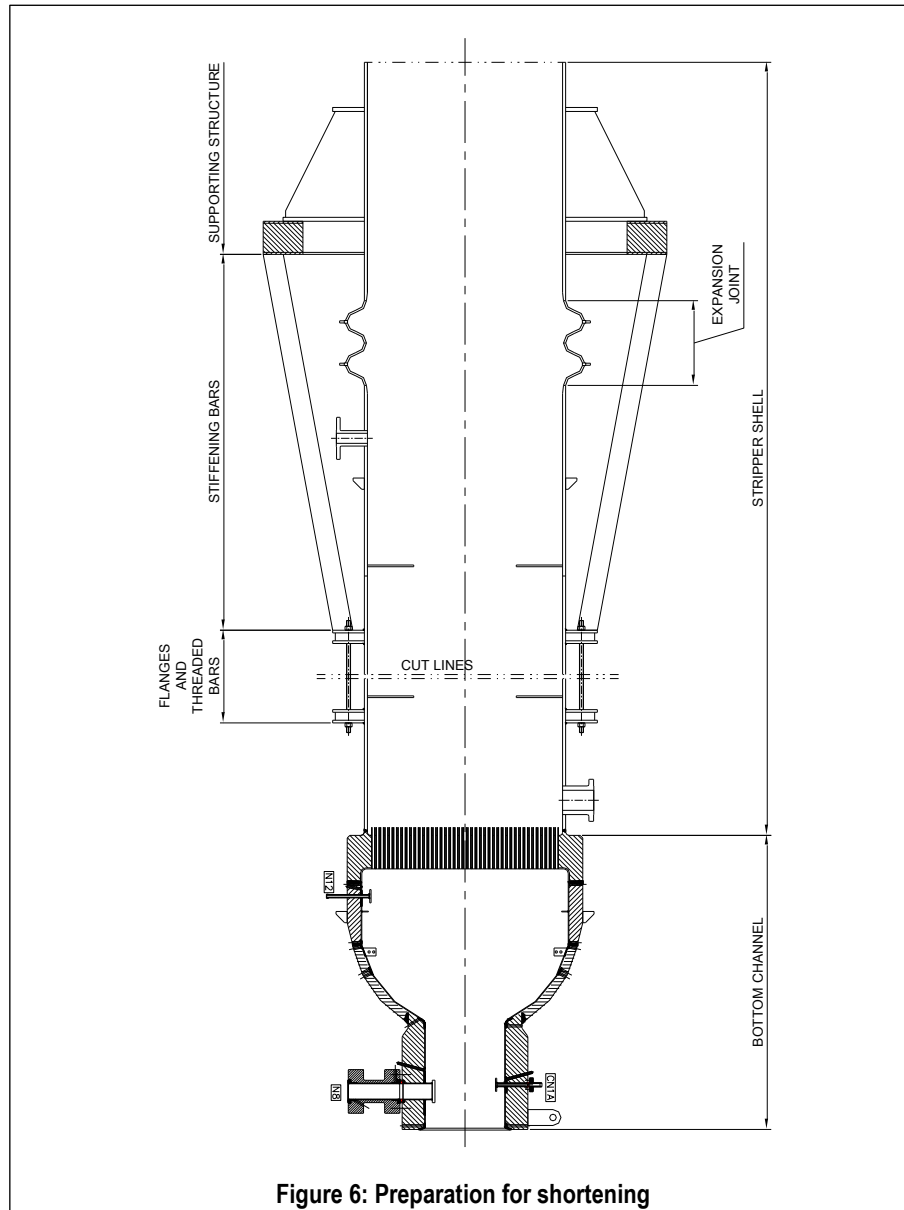
Figure 6: Preparation for shortening

To achieve this we designed two flanges to be welded on the shell, joined by No. 16 x M30 threaded bars. Between them a 40mm wide cut would be made into the shell. Bypass of the expansion joint would be obtained by No. 8 stiffening bars welded between the top lifting flange and the supporting structure.

The scheme in Figure 6 shows graphically the preparation that we made. Lifting is obtained by tightening the nuts of the threaded bars. The point of reaction for the strain is shifted to the supporting structure through the stiffening bars without stressing the expansion joint.

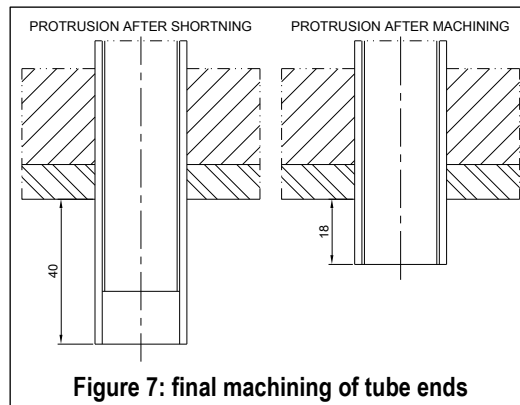
Figure 7: final machining of tube ends

After the bottom channel is lifted the tubes extend by about 30mm beyond the tubesheet surface and must be machined to the required protrusion of 18mm before welding the TTS joints. In this process the area of the tube from which the zirconium was removed when the stripper was manufactured is completely eliminated, along with the corroded tube end. What is left is a solid bimetallic tube protrusion.

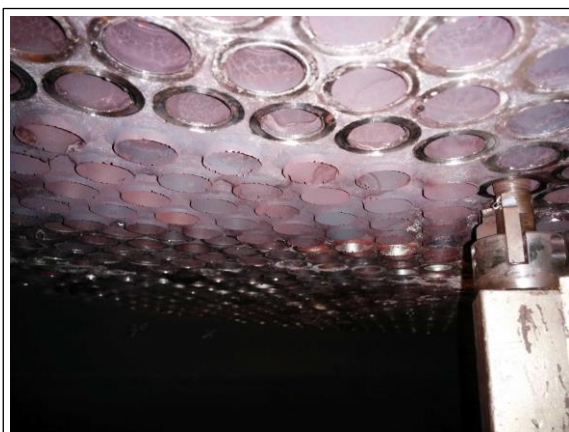
Figure 8: reaming of tube ends

The machining of the TTS joints took longer than expected because, being the very first experience of the sort, we proceeded very carefully and repeated the sequence reaming / PT validation / reaming several times before all joints were completely removed.

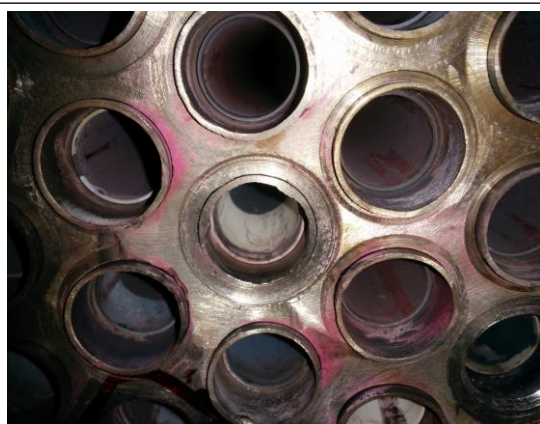
**Figure 11: jammed tube (center)**

- The shell gap was reduced by 6mm only, then the tightening force increased to the point of making it impossible to proceed any further.
- No. 112 tubes, irregularly distributed across the surface of the bottom tubesheet, were jammed into their tubesheet holes due to some dirt or corrosion deposits and would not slide downwards.
- The other tubes slid downwards until they protruded by 3-4mm, but the amount of protrusion was not uniform throughout the surface. It was shorter in the areas where the number of jammed tubes was higher and longer in the areas which were freer to slide.

Finally we decided to machine the jammed tubes on the top tubesheet to allow them to slide upwards rather than forwards.

This procedure was successful although it had the downside that the affected tubes must be plugged. No. 29 of them belonged to the group of tubes that had already been plugged, so after this modification the total number of plugged tubes increased by:  $(112 - 29) = 83$  which, added to the 57 existing ones, brought the total to No. 140 (No. 141 because one tube was reamed by mistake).

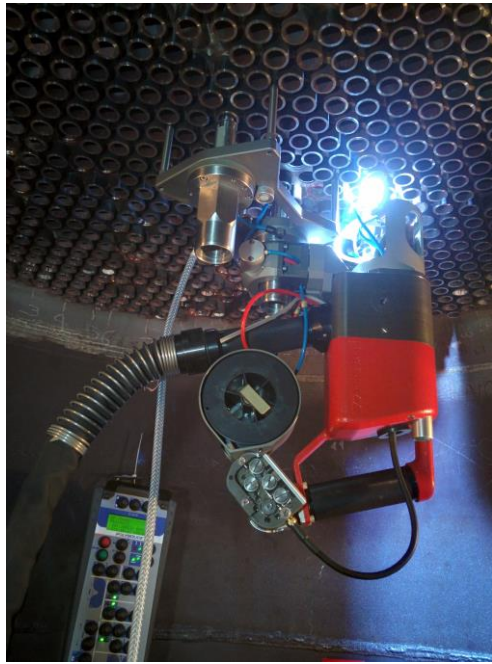
Figure 15: welding the new TTS joints

The machining of the tubes to 18mm of protrusion was a straightforward activity were we faced not incidents. Welding, though, in some instances was made difficult by pockets of solidified carbamate solution trapped in the interstice between some of the tubes and the tubesheet. The carbamate solution, when heated by the welding arc, would sublime into gaseous phase, expanding rapidly and blowing out through the molten pool, creating a defect in the ongoing joint and sometimes also in the nearby ones and forcing the weld to stop. Most of the time this defect was corrected simply by remaking the root pass over the existing root pass, while in five cases we were forced to ream the first root pass before remaking it. In spite of all the difficulties encountered the welding activity took roughly the estimated time.

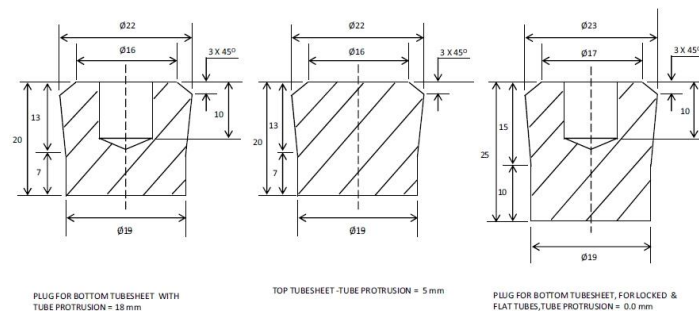
Figure 15. Details of taper plugs used during shortening

IFFCO designed different types of plugs for top and bottom tubesheet and for tubes having no protrusion from the tubesheet surface (the tubes that were jammed into the bottom tubesheet) and tubes that protruded from the tubesheet surface (some of the tubes previously plugged, which did slide down but were not reliable)
