# The AXO WELDING and GPIC Partnership

## A Benchmark in Realizing High Safety Standards and High On-Stream Figures

This article explains the work done jointly by GPIC and AXO WELDING in this direction, to prepare for and to carry out the works on the high pressure loop during seven turnarounds, between 2003 and 2018.

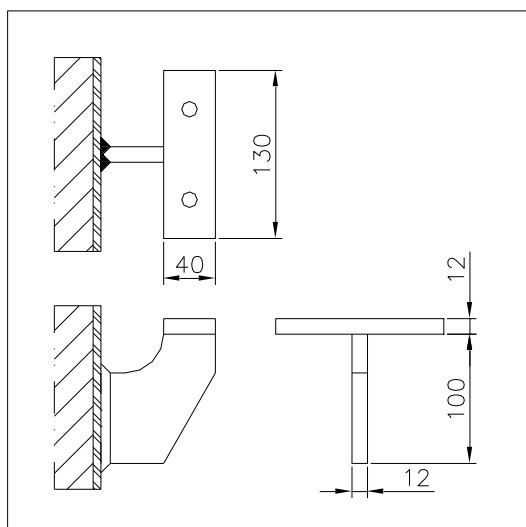
To fulfill all these requirements GPIC decided to begin a relining project and – at the same time – to replace all tray supports. The material of the new liner and supports would be improved to 25.22.2CrNiMo – which has proven to have a much lower corrosion rate at the process conditions of SAIPEM reactor – and the design of the new supports would be changed to that shown in figure 5, in order to make it easier to inspect them.

**Figure 5:** design of new tray supports

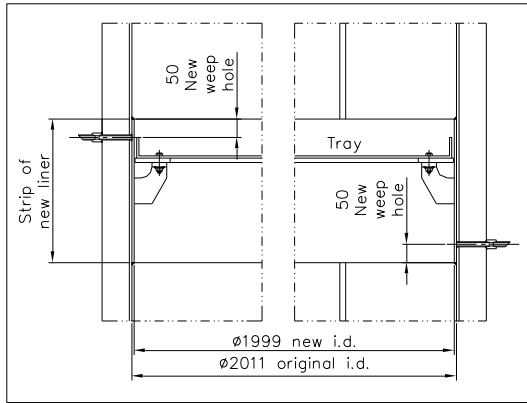
The relining project would be carried out in phases, with only a part of the reactor surface being covered at each turnaround. To begin with, then, in 2003 No. 12 strips of new liner were installed at the location of tray #1 through tray #12. The strips of new liner were fabricated complete with new supports and to guarantee leak detection, No. 2 new weep holes were made for each strip. Figure 6 illustrates the scheme of installation of the new strips of new liner.

**Figure 6:** scheme of installation of new liner strips

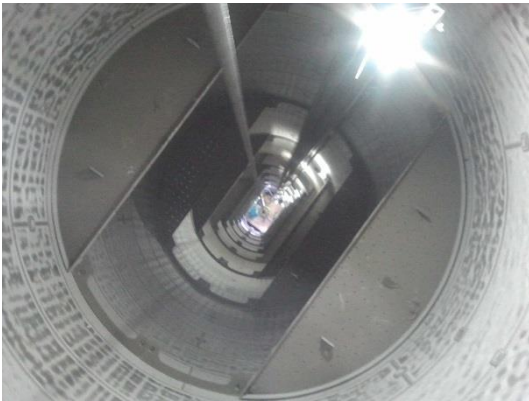
The planned modification required an extensive amount of work to be carried out inside the reactor, a potentially dangerous environment where the hazards typical of a confined space sum up with the hazards of working at height. The solution adopted to address this HSE issue consisted in:

Figure 7 shows the inside of the reactor as seen from the top manway, after the implementation of the actions.

**Figure 7:** work in progress inside the reactor

- A new way to transport personnel and materials in and out of the reactor by means of an electric hoist and manbaskets,
- A specially-designed aluminum platform to support the personnel at the working elevation
- the use of a powerful chiller/blower unit connected to the bottom nozzles to guarantee a constant air exchange and a comfortable working environment.
- A cable-intercom system to guarantee good communication between the workers inside the reactor and those on top and outside it.
- A specifically procured, low-voltage illumination system based on a number of lamps attached to a single cable.

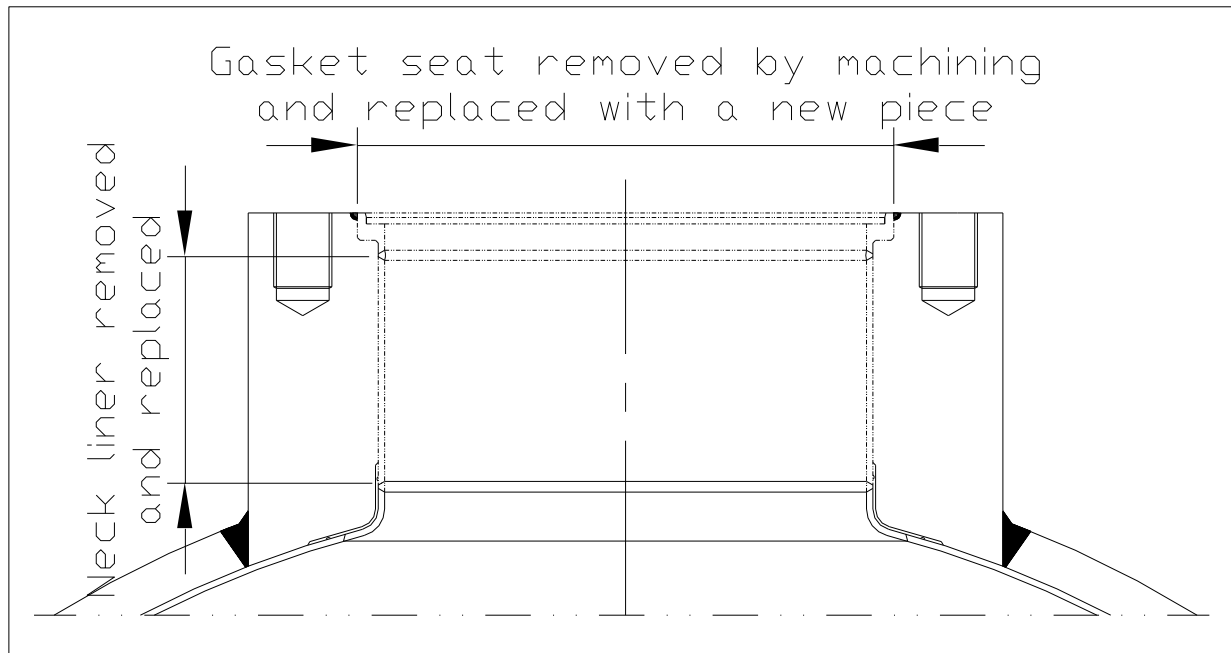
| Table 3: risk analysis and action plan for turnaround 2007 | | | | | |
|--|---|---|--|--|--|
| Urea Reactor | R-8201 | Corrosion on the sealing surface of the manway cover and on the liner of the manway neck | Prevent leaks<br>Increase the equipment safety and reliability | Replace gasket seat and nozzle liner on top manway | Material upgrade to 25.22.2CrNiMo |

Figure 8: scheme of relining of manway

- The replacement of the stainless steel ring that forms the seat of the manway gasket (see figure 8)
- The relining of the top dome and the area above tray #1
- The replacement of some trays

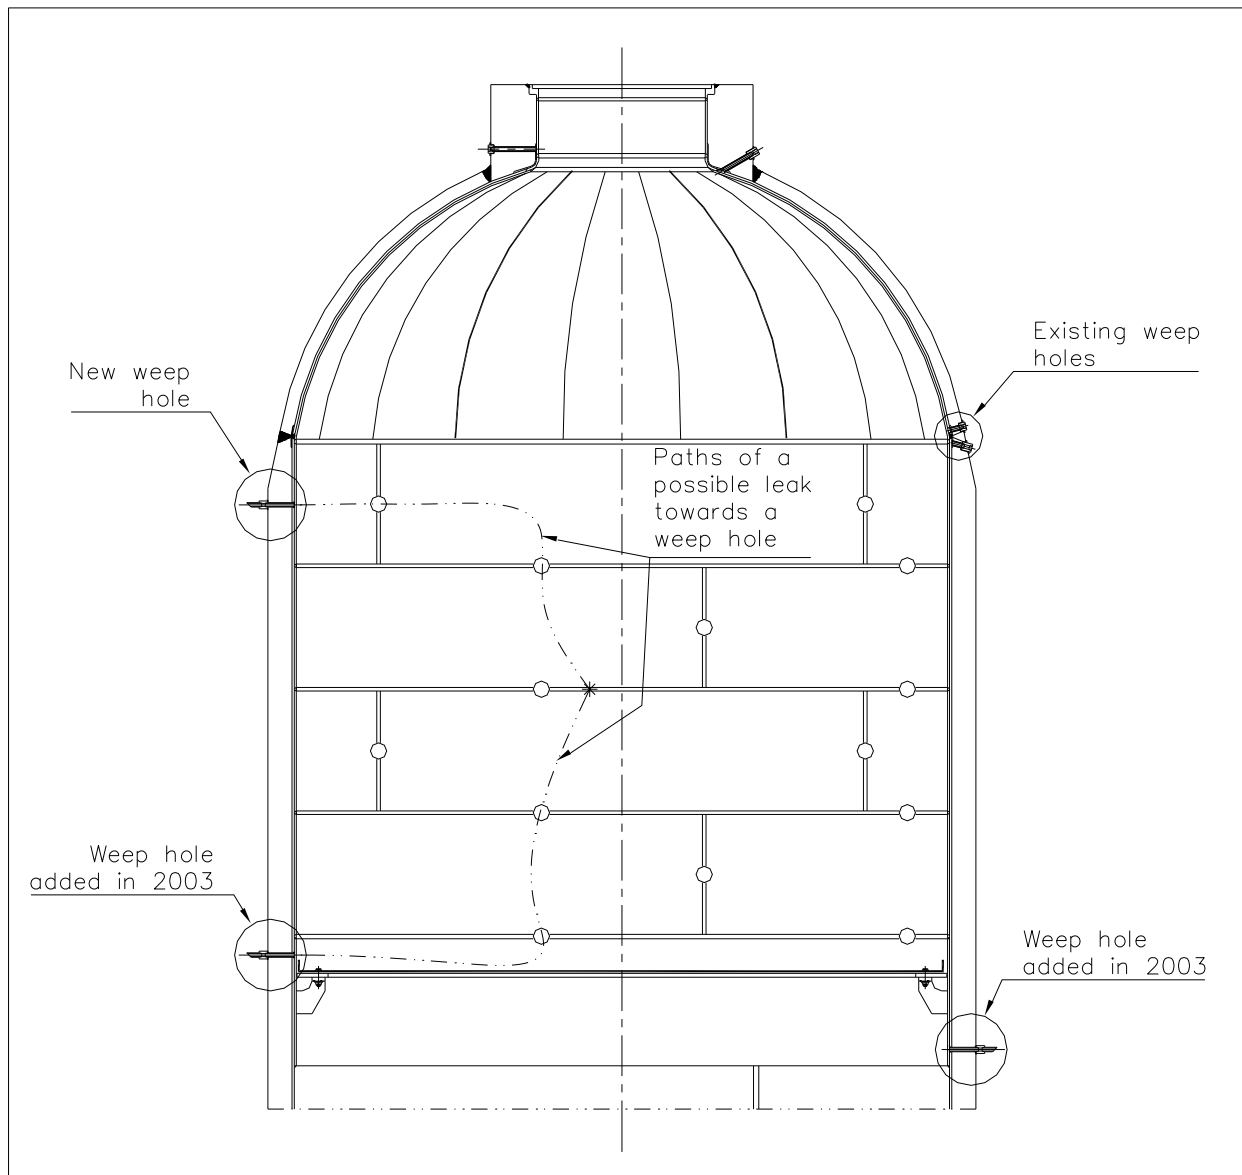
Figure 9 shows the principle of the relining job: the new liner is applied in tiles – or strips – small enough to be introduced into the manway  $\text{\O}500\text{mm}$ . The tiles are welded on the existing liner and the leak detection is guaranteed by two features:

The presence of gaps in the weld provide a way for a possible leak to get to the nearest weep hole

Figure 9: scheme of reactor relining

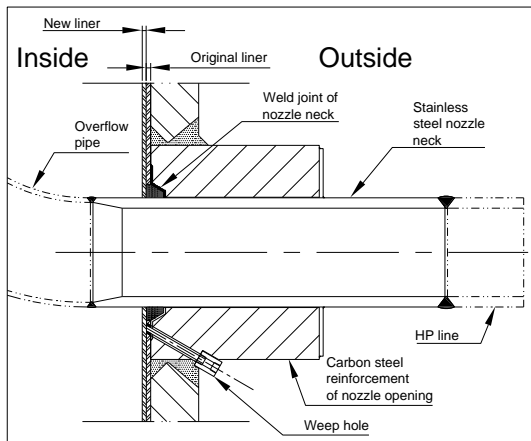
| Table 7: risk analysis and action plan for turnaround 2018 | | | | | |
|--|---|---|--|--|---|
| | | Corrosion of solution outlet nozzle N1 | Increase safety and reliability of equipment and on-stream time. | Removed and replaced existing N1 nozzle. | Material upgrade to 25.22.2CrNiMo |

**Note:** The area around nozzle N1 had already been subject to relining. The initial layout was as shown in figure 10

**Figure 10** initial layout of N1

1. Using a manual grinder, cut free the nozzle neck from the high pressure pipe outside the reactor and from the internal overflow pipe

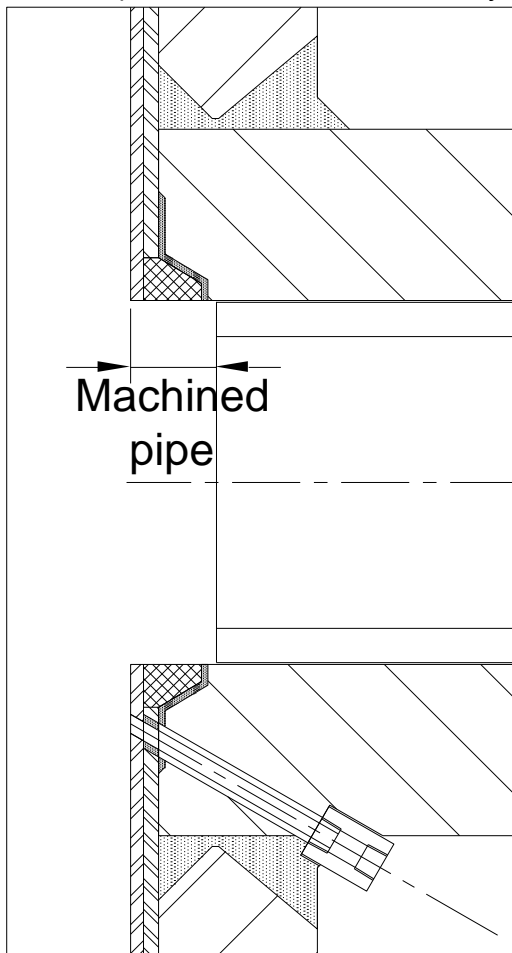
**Figure 11:** machined nozzle

2. Extend the weep hole through the thickness of the liner by manual drilling.
3. Cut the internal stub flush to the internal surface
4. Machine the pipe through the whole thickness of the weld joint (Figure 11)
5. Remove the nozzle and machine the weld joint, taking care not to remove the stainless steel buffer layer that separates the stainless steel weld joint from the carbon steel shell (Figure 12)

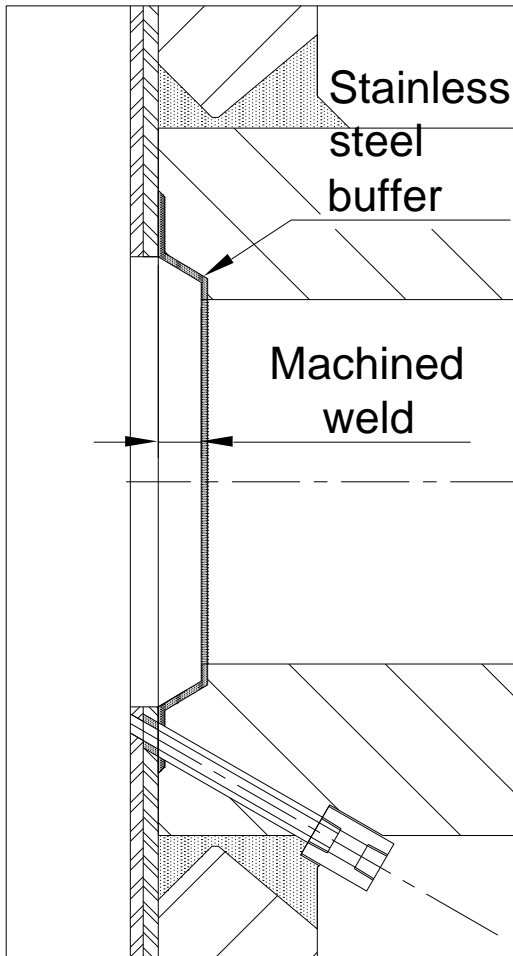
**Figure 12:** nozzle N1 after removal of pipe and machining of weld

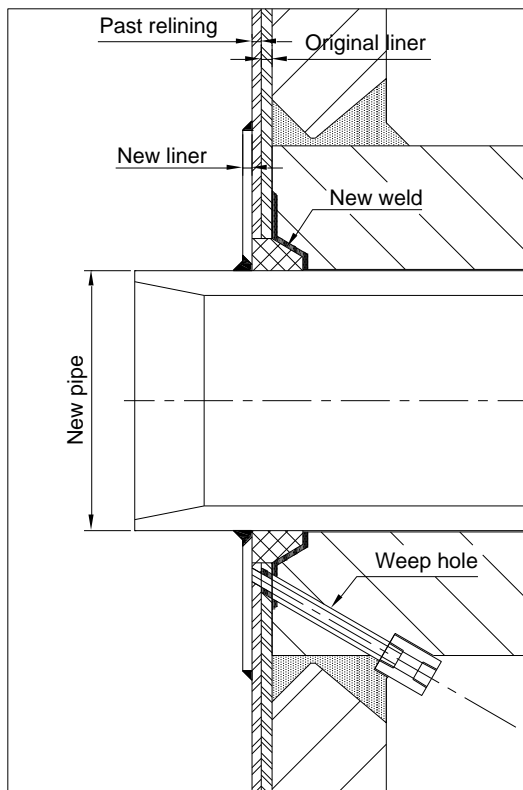
The modified layout after the replacement is shown in Figure 13

Figure 13: final layout of nozzle N1

7. Grind the weld flush with the liner surface
8. Add a new layer of lining in the form of a ring surrounding the nozzle, to protect the weld from contact with the process fluid.
9. Leak detection of the welds of the additional liner is guaranteed by the extended weep hole.
