# Urea Reactor Pro-Active Modification & Repair: GPIC Experience

**Abdul Khader Kukkady**

Gulf Petrochemical Industries Co.,  
P.O.Box 26730, Kingdom of Bahrain

**Mauro Orsini**

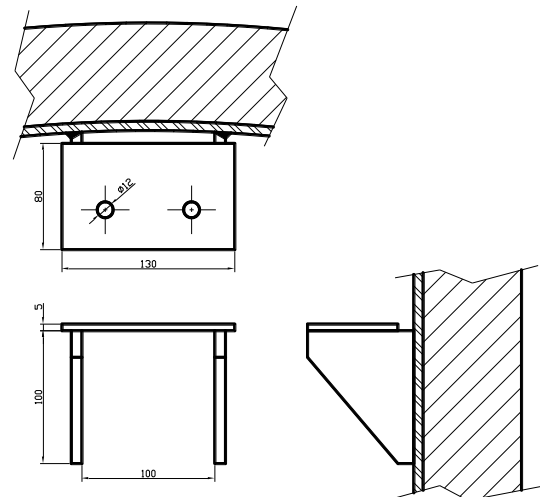
**Figure 2:** original tray support design

Figure 2 shows the tray support design as originally supplied with the reactor.

<b>1999</b>		- Localized corrosion cavities.	- Localized corrosion cavities in the welds between the tray support and the liner, mostly on the top 9 trays but with some isolated spots below tray #14		- Same as 1998	<i>More progress in the corrosion of the welds</i>
<b>2000</b>			- Severe corrosion on 90% approximately of support-to-liner welds.	- Severe corrosion on pipe longitudinal weld and HAZ. - Severe corrosion on bracket-to-liner welds.	- Extensive repair of support welds. - Removal of 1/2 of a support on tray #13, due to a defect that was not possible to remove	<i>Corrosion rate apparently increasing. Current support design may hinder inspection and repair. Examination of removed 1/2 support raised suspicion that support-to-liner welds might not be full penetration.</i>

- 1) All tray support gussets and solution outlet pipe brackets should be replaced in the next turnaround, possibly redesigning the support shape to minimize the number of welds on the liner and to have full access to weld inspection and maintenance activities.
- 2) The defective longitudinal and circumferential welds of the liner should be refurbished, in order to minimize the further development of an undercut on the side of the welds.
- 3) The relining of the upper section of the reactor was taken into consideration but, on the base of the results of the thickness measurement, case history of other plants

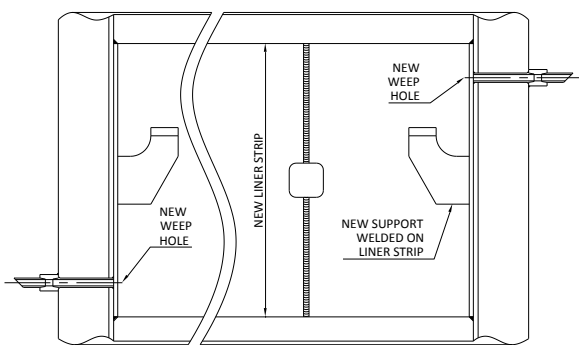
**Figure 3:** option 2, single support gusset with backing strip

**Option 2:** install tray supports of new design welded on a backing strip which, in turn, would be welded to the existing liner.

recommendation for support replacement after the preliminary inspection was to carry out option 2 for trays #1 to #7 and option 1 for the other trays but, due to interference between the welds of the new option 1 supports and the existing vertical liner welds for trays # 8 through #12, the final decision to apply option 2 to tray #1 through 12 and option 1 only for the last two trays.

- As anticipated severe corrosion/deterioration was observed in the welds and in the parent metal of the tray supports and of the overflow pipe support brackets. Removal of tray supports and pipe brackets gave evidence that the welds connecting them to the liner were not full penetration. The areas where the supports and bracket welds lay were checked visually and by liquid penetrant (PT) examination. Weld buildup was carried out at trays #13 & #14, where the old support location would be exposed to the process fluid since the new liner strip had not been added.

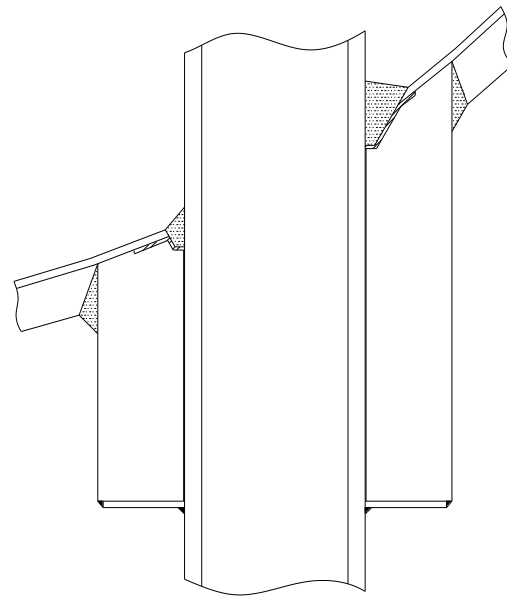
**Figure 4:** original nozzle joint layout

In addition to the above, and as a result of discussion with other urea specialists, it was also agreed to modify the inlet and outlet nozzles of the reactor by adding a cover strip over the welds and providing them with a leak detection system, since these welds were not monitored by weep holes and the possibility of a weld defect was present, due to vibration of the nozzles, specially the NH<sub>3</sub> inlet.

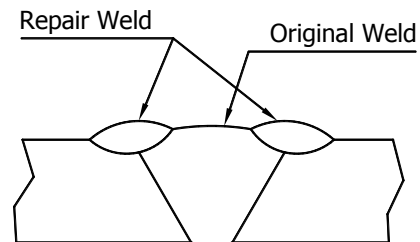
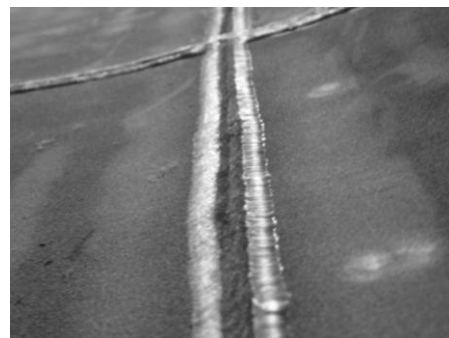
**Figure 8:** weld repair below tray No. 14

- 2) On the areas that had not been repaired in turnaround 2003, excessive corrosion and undercuts were observed on the circumferential and longitudinal welds and HAZ. The observation was noted all over the original liner welds. The maximum undercut depth measured was approx. 3.5mm. The most affected areas were from the top dome and up to the 9th tray. The defects were classified based on severity of attack to allow prioritization for repair. Given the available time, again only the most affected areas were repaired. All defects were ground out up to 3-4mm of depth and repaired by welding using 25-22-2 filler wire. Liquid penetrant (PT) and ferrite check were carried out after welding. It was recommended to refurbish the full liner welds on the next turnaround.

- 1) The supports of tray #14 and tray #13 would be replaced with the back strip arrangement.
- 2) The straight portion of the overflow pipe would be replaced. The replacement pipe, though, would be still 316L urea grade, as 25.22.2CrNiMo pipe delivery time would exceed the turnaround date.
- 3) The liner welds between the bottom dome and tray No. 14 would be repaired on the side, as shown in figure 8:

- Grinding of repair area to a maximum depth of 1.5mm
- Make repair weld by TIG using 25.22.2 rod
- Perform PT examination on new weld

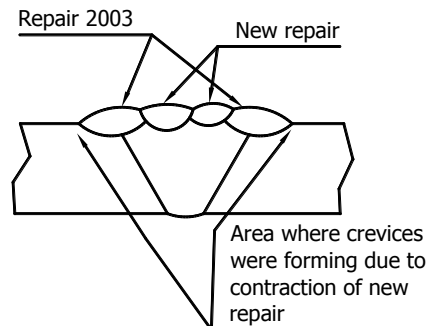
**Figure 9:** weld repair above tray No. 14

The activities proceeded as planned from the bottom end up to tray No. 10. At this elevation the PT examination of the weld shown a defect forming between the repair weld bead made in Turnaround 2003 and the parent metal (see figure 9). Probable cause was established to be the contraction of the new repair weld acting on the HAZ of the old one. After discussion with the contractor it was agreed to extend the repair to the whole width of the weld, including the repair welds made during Turnaround 2003.

- 4) The liner welds above tray No. 14 would be repaired in the center of the weld bead, between the repairs made during Turnaround 2003, as shown in Figure 9:

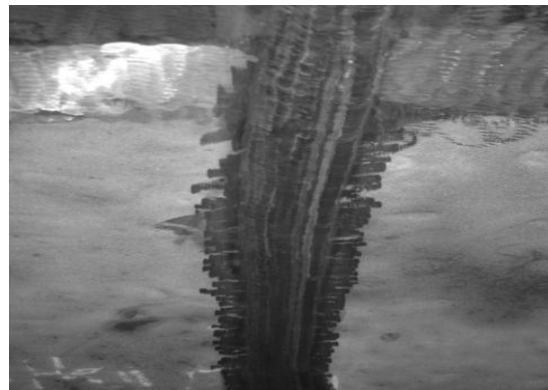
**Figure 10:** repair on top dome

Furthermore, according to the original plan the whole of the passivation scale was to be removed from the top dome by grinding. This activity, though, was suspended due to the scale being too hard and the grinding activity removing some of the liner material.

Due to the amount of grinding and welding to be carried out on the dome, it was agreed to start the repair on one weld and then re inspect before finalizing the repair for the rest of the welds. During the inspection of the 1st repaired weld, cracks developed in what appeared to be

the parent metal. Close inspection revealed that the cracks had developed in the scale due to un-complete cleaning before welding, the cracks were easily removed with shallow grinding not more than 0.5mm deep. It was therefore agreed to grind the area 100mm on both side of the welds and up to a remaining wall thickness of 8 mm on the liner parent metal to ensure complete removal of scale. The new procedure was adopted after experimenting on one weld which was found defect free after welding. Cracks were due to the high hardness in the scale.

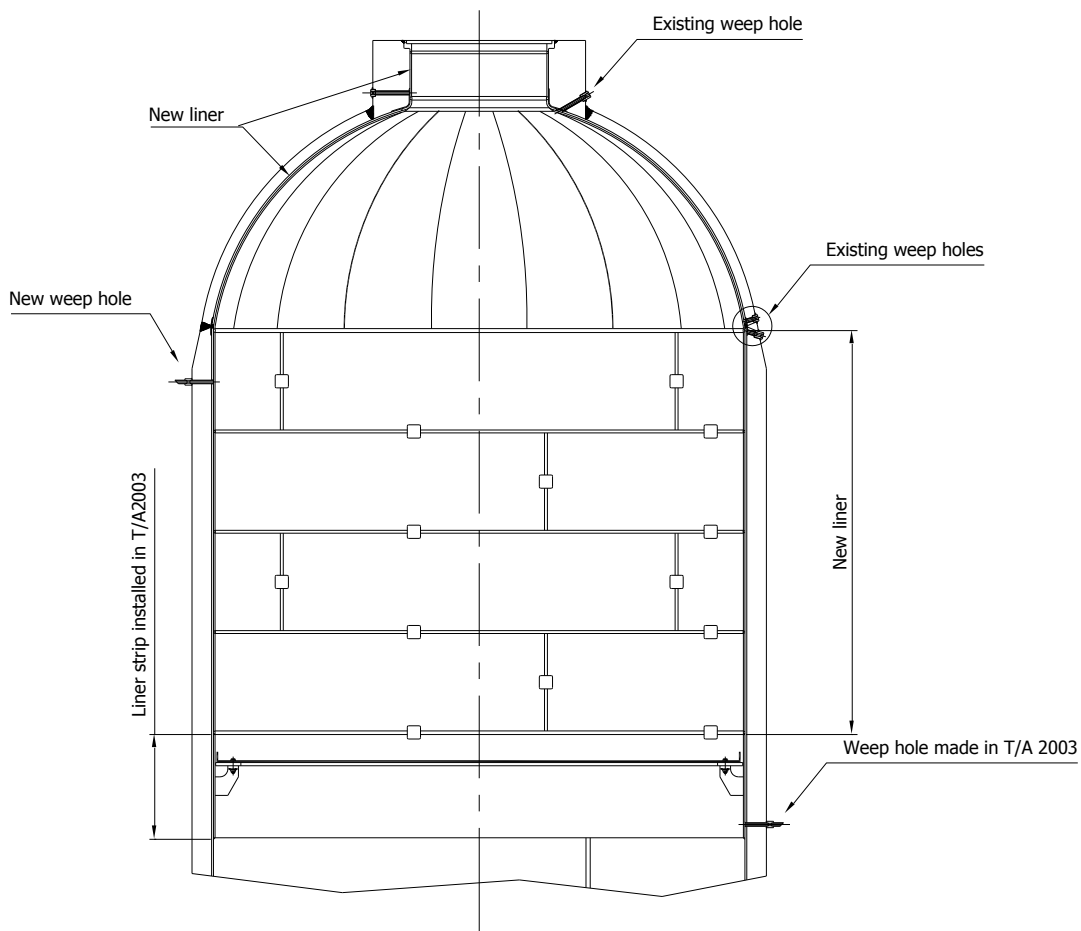
**Figure 11:** relining scheme

The common trait of all the inspections and repair activities carried out since the installation of the reactor was the evidence of an insufficient quality of the liner welds, which would potentially compromise the reliability of the equipment. Experience made in 2003 and 2005 turnarounds shown that a repair procedure that would improve the weld quality to the standard required for a reliable urea reactor was not technically achievable. For this reason, starting from T/A 2007, a reactor relining plan was put in place.

The relining plan consists in applying a new liner made of 25.22.2CrNiMo plates over the existing 316L UG liner. The plates of the new liner are 6mm in thickness, and they are rolled and cut into strips short enough to be inserted through the 510mm manhole. The strips are fit and welded into the reactor, each course being

divided into three 120° sections. All longitudinal and circumferential welds connecting the new liner strips are interrupted by a weld gap, which is plugged by a cover strip. This arrangement allows a possible leak developing anywhere in the new welds to reach the closest weep hole passing through the weld gaps. Special attention had to be paid during the design phase to the weep holes arrangement, to minimize the need of new weep hole and to consent a rapid recognition of the defective spot in case of a leak.
