Shortening of two bimetallic urea strippers in situ: extension of the operational life and reliability by refurbishment.

I.C. Jha
Executive Director
IFFCO Aonla Unit
Uttar Pradesh, INDIA

Mauro Orsini
CEO
AXO WELDING SRL
RAVENNA, ITALY

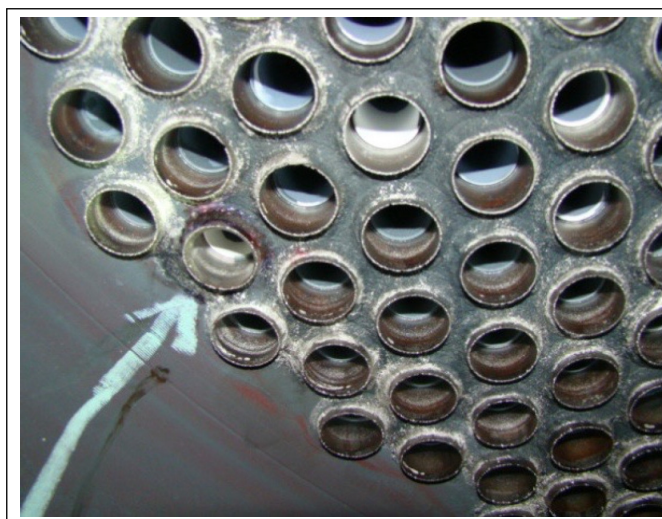
Figure 2: Condition of the bottom TTS welds in 2012

In year 2012 the first leak was experienced. As a result, plant steam got contaminated with NH₃ and CO₂ which caused sudden increase in conductivity of LP steam at E-5 outlet and hence the plant was stopped to attend the repair.

During inspection, severe corrosion in bottom portion of tube to tube sheet weld joints were observed (Figure 2). Weld deposits had developed porosities. During soap solution test, on pressurizing the shell side with air at 3.5 kg cm⁻², air leak from 13 nos. tube to tube sheet weld joints was observed.

IFFCO tried to carry out the repair of the tubes by welding but the tube ends – which were already thinned-down – would not stand it, and the repair attempt only caused more leaks from the tubes internal surface. Finally all of the 13 tubes were plugged. When welding the plugs, the affected tube-to-tubesheet welds were covered by weld overlay (Figure 3).

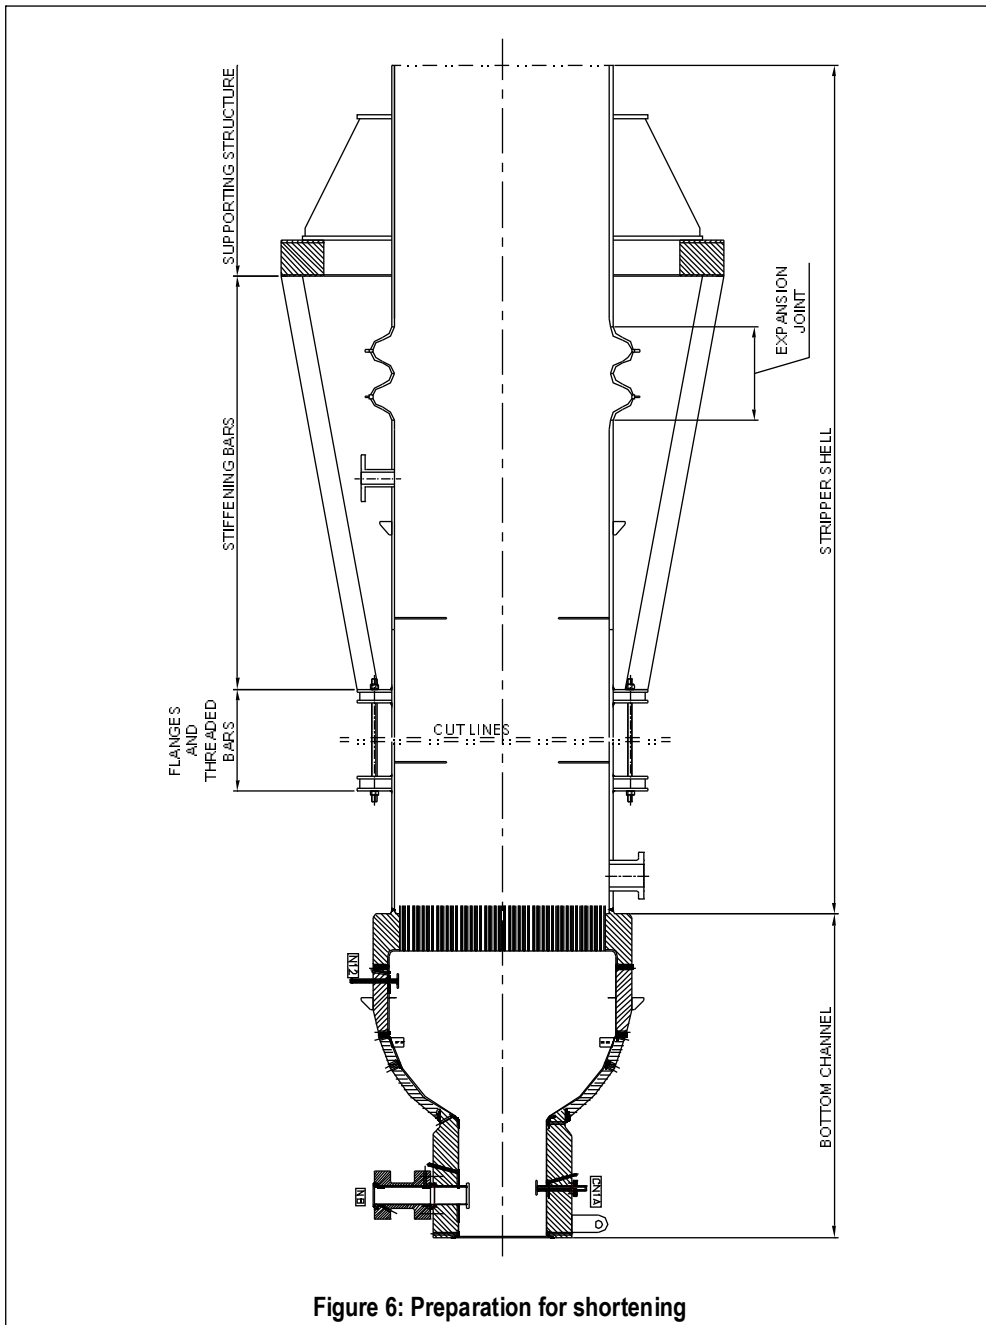
Figure 6: Preparation for shortening

To achieve this AXO designed two flanges to be welded on the shell, joined by No. 16 x M30 threaded bars. Between them a 40mm wide cut would be made into the shell. Bypass of the expansion joint would be obtained by No. 8 stiffening bars welded between the top lifting flange and the supporting structure.

The scheme in Figure 6 shows graphically the preparation that AXO made. Lifting is obtained by tightening the nuts of the threaded bars. The point of reaction for the strain is shifted to the supporting structure through the stiffening bars without stressing the expansion joint.

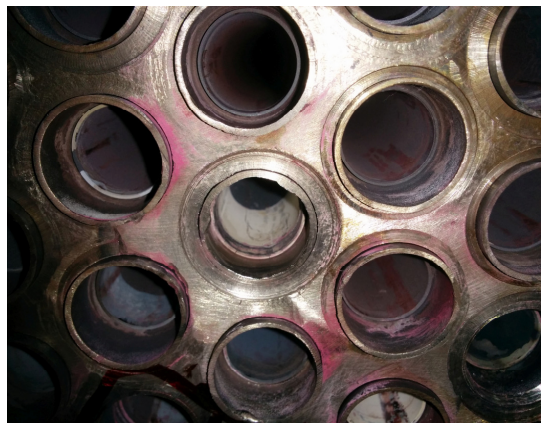
- The shell gap was reduced by 6mm only, then the tightening force increased to the point of making it impossible to proceed any further.
- No. 112 tubes, irregularly distributed across the surface of the bottom tubesheet, were jammed into their tubesheet holes due to some dirt or corrosion deposits and would not slide downwards.
- The other tubes slid downwards until they protruded by 3-4mm, but the amount of protrusion was not uniform throughout the surface. It was shorter in the areas where the number of jammed tubes was higher and longer in the areas which were freer to slide.

Figure 11: jammed tube (center)

Finally it was decided by AXO and IFFCO team to machine the jammed tubes on the top tubesheet to allow them to slide upwards rather than going down.

This procedure was successful although it had the downside that the affected tubes must be plugged. No. 29 of them belonged to the group of tubes that had already been plugged, so after this modification the total number of plugged tubes increased by: $(112 - 29) = 83$ which, added to the 57 existing ones, brought the total to No. 140 (No. 141 because one tube was reamed by mistake).

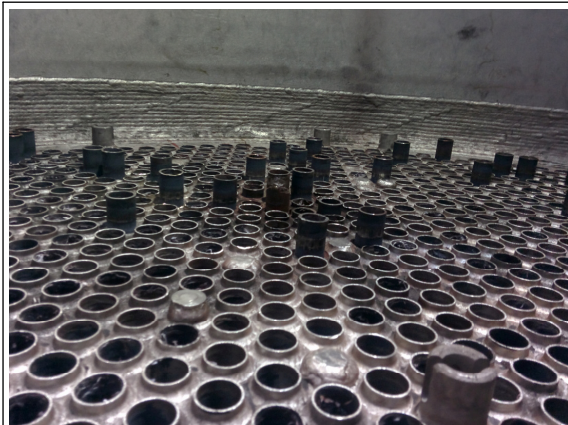
Figure 13: tubes protruding upside

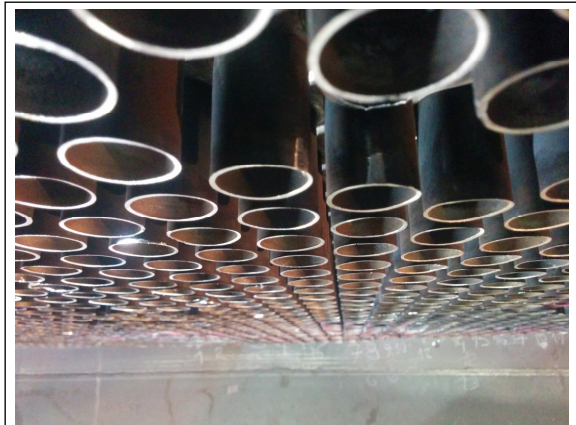
Figure 14: tubes protruding downside
