# Shortening of two bimetallic urea strippers in situ: extension of the operational life and reliability by refurbishment.

*Two bimetallic urea strippers which had been in service for more than 20 years were reaching the end of their operational life due to corrosion at the bottom tubesheet that affected the tubesheet, the tube protrusion and the tube-to-tubesheet weld joints*

*This paper details a unique restore operation that extended the units' life and reliability by several years and consisted in removing and restoring the tube protrusions and tube-to-tubesheet joints at the bottom tubesheet by shortening the stripper length of 40mm*

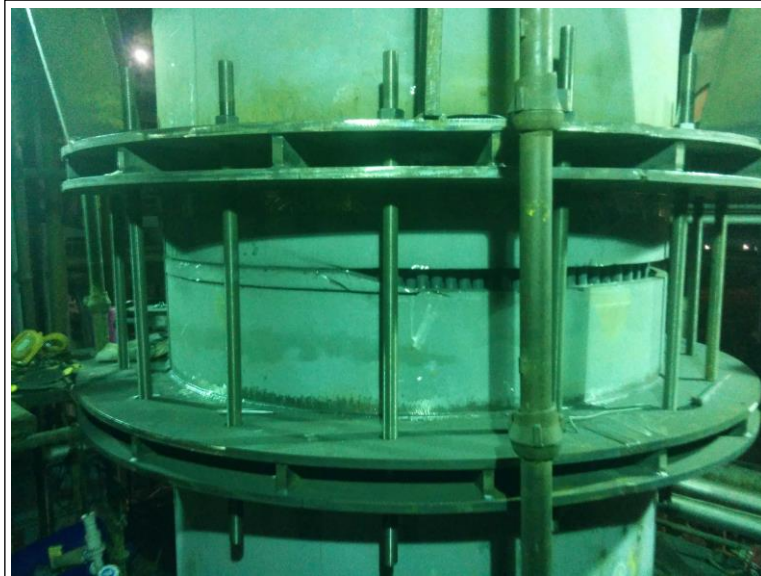
Figure 10: cutting the shell

After completion of this part and running of steam from the shell side through the tube-tubesheet interstices, we cut the shell without any particular difficulty.

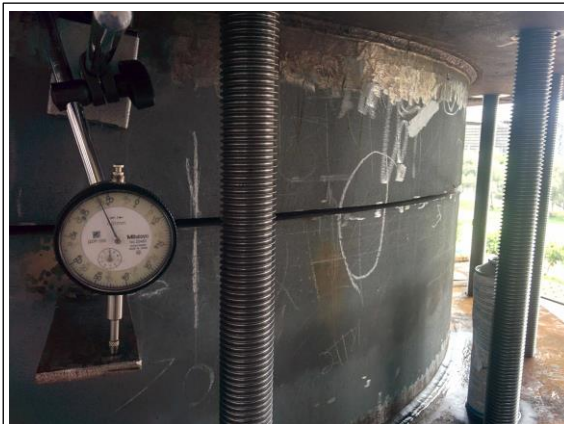
**Figure 12: bottom lifted completely**

The first real problem emerged when we lifted the bottom. The first tightening of the threaded bars started on the nightshift of July 15th and proceeded during the following dayshift, and the result that it produced was:

- The shell gap was reduced by 6mm only, then the tightening force increased to the point of making it impossible to proceed any further.
- No. 112 tubes, irregularly distributed across the surface of the bottom tubesheet, were jammed into their tubesheet holes due to some dirt or corrosion deposits and would not slide downwards.
- The other tubes slid downwards until they protruded by 3-4mm, but the amount of protrusion was not uniform throughout the surface. It was shorter in the areas where the number of jammed tubes was higher and longer in the areas which were freer to slide.

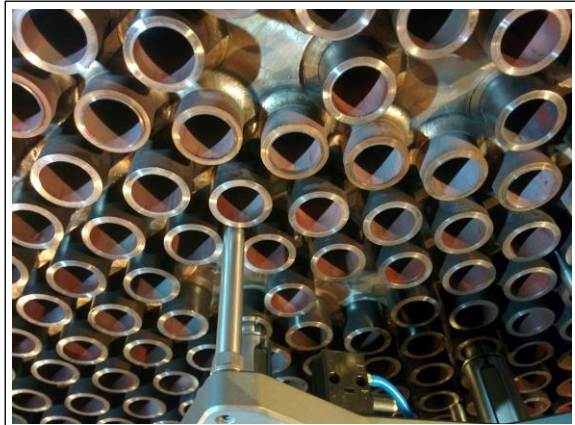
Figure 16: welding the new TTS joints

The machining of the tubes to 18mm of protrusion was a straightforward activity were we faced not incidents. Welding, though, in some instances was made difficult by pockets of solidified carbamate solution trapped in the interstice between some of the tubes and the tubesheet. The carbamate solution, when heated by the welding arc, would sublime into gaseous phase, expanding rapidly and blowing out through the molten pool, creating a defect in the ongoing joint and sometimes also in the nearby ones and forcing the weld to stop. Most of the time this defect was corrected simply by remaking the root pass over the existing root pass, while in five cases we were forced to ream the first root pass before remaking it. In spite of all the difficulties encountered the welding activity took roughly the estimated time.
