Shortening of two bimetallic urea strippers in situ: extension of the operational life and reliability by refurbishment.

I.C. Jha
Executive Director
IFFCO Aonla Unit
Uttar Pradesh, INDIA

Mauro Orsini
CEO
AXO WELDING SRL
RAVENNA, ITALY

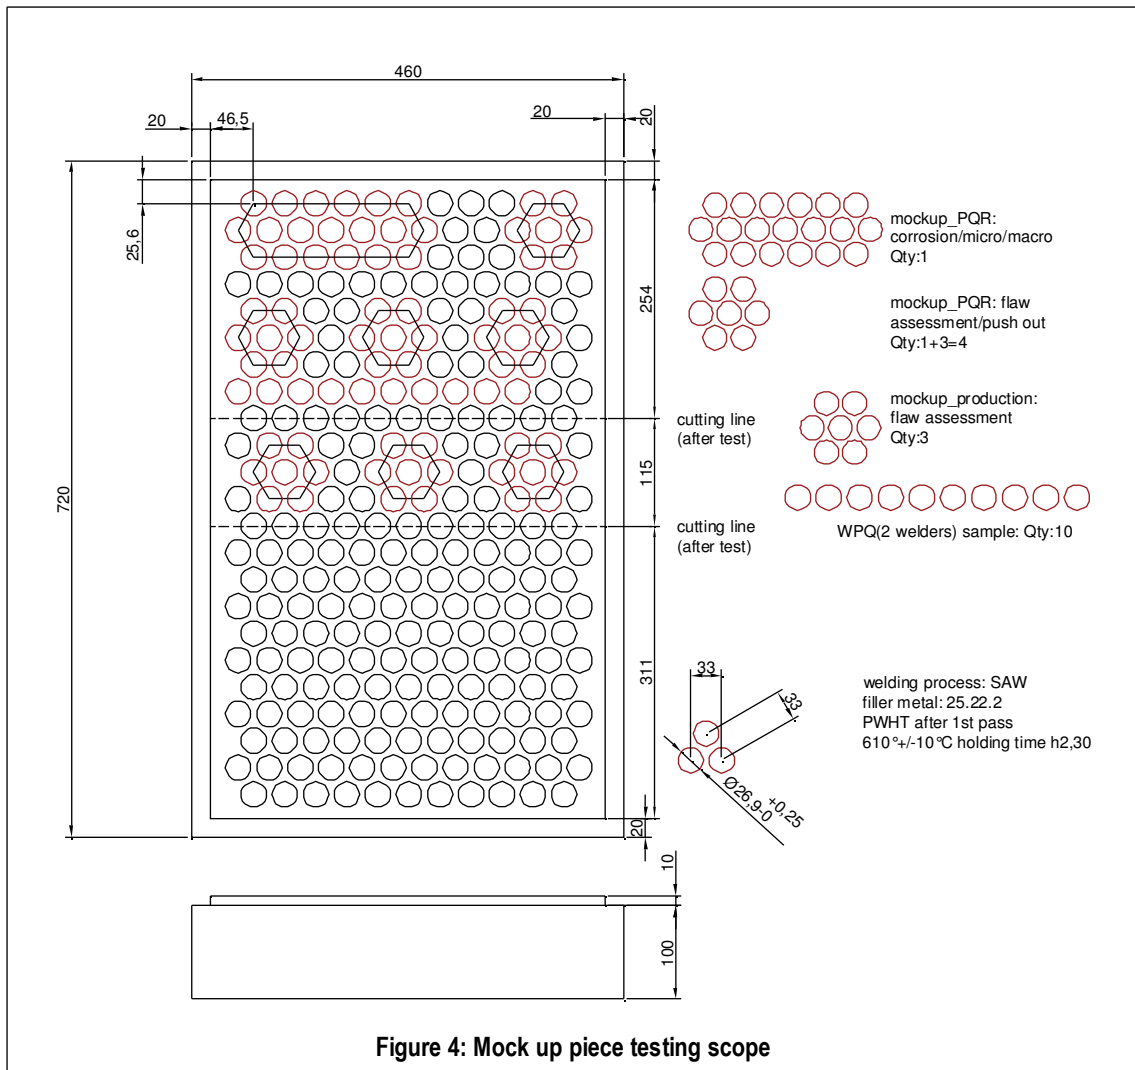
When the mock up piece was ready, AXO organized a test welding session at AXO WELDING workshop at the presence of SAIPEM and Third Party inspectors, during which 92 tubes on 8 rows were welded. When welding was complete, a group of No. 19 tubes was selected for metallographic/corrosion/macro testing and No. 4 groups of No. 7 tubes each were identified for flaw assessment/mechanical testing according to SAIPEM specification CR-UR-528. The position of the selected tubes is shown in the sketch in figure 4:

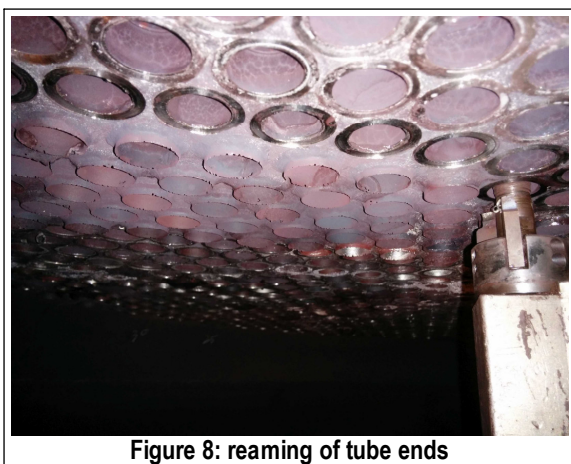
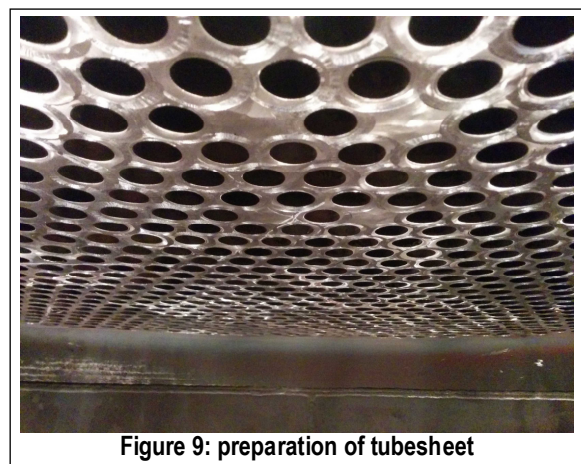
The machining of the TTS joints took longer than expected because, being the very first experience of the sort, AXO team proceeded very carefully and repeated the sequence reaming / PT validation / reaming several times before all joints were completely removed.

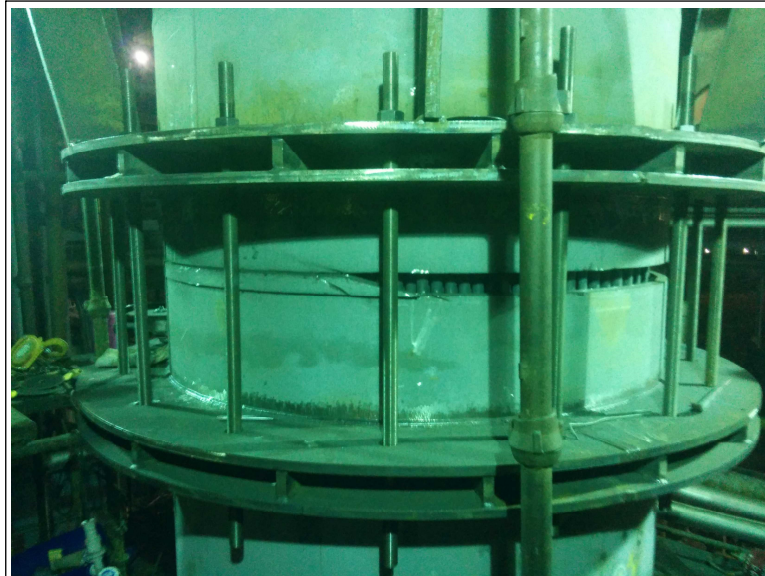
Figure 10: cutting the shell

After completion of this part and running of steam from the shell side through the tube-tubesheet interstices, AXO team cut the shell without any particular difficulty.

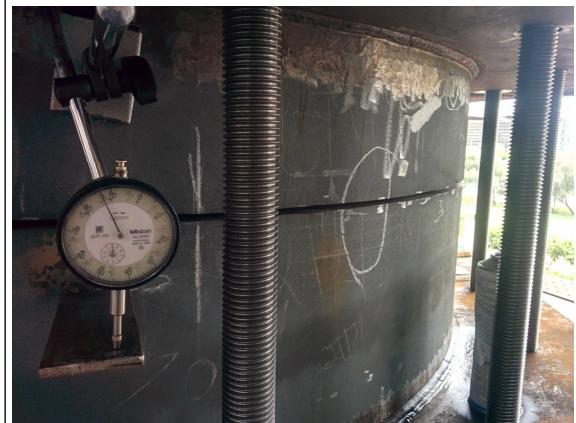
Figure 12: bottom lifted completely

The first real problem emerged when we lifted the bottom. The first tightening of the threaded bars started on the nightshift of July 15th and proceeded during the following dayshift, and the result that it produced was:

- The shell gap was reduced by 6mm only, then the tightening force increased to the point of making it impossible to proceed any further.
- No. 112 tubes, irregularly distributed across the surface of the bottom tubesheet, were jammed into their tubesheet holes due to some dirt or corrosion deposits and would not slide downwards.
- The other tubes slid downwards until they protruded by 3-4mm, but the amount of protrusion was not uniform throughout the surface. It was shorter in the areas where the number of jammed tubes was higher and longer in the areas which were freer to slide.

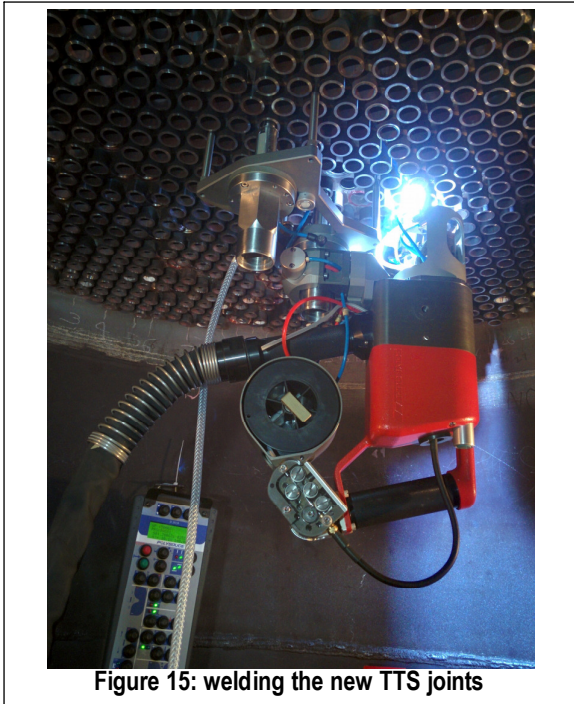
Figure 15: welding the new TTS joints

The machining of the tubes to 18mm of protrusion was a straightforward activity where we faced not incidents. Welding, though, in some instances was made difficult by pockets of solidified carbamate solution trapped in the interstice between some of the tubes and the tubesheet. The carbamate solution, when heated by the welding arc, would sublime into gaseous phase, expanding rapidly and blowing out through the molten pool, creating a defect in the ongoing joint and sometimes also in the nearby ones and forcing the weld to stop. Most of the time this defect was corrected simply by remaking the root pass over the existing root pass, while in five cases we were forced to ream the first root pass before remaking it. In spite of all the difficulties encountered the welding activity took roughly the estimated time.
